Misalignment and balancing problems at a refinery

by **Mariano Sanchez Cabra**
Chief Engineer, Mechanical
Maintenance Department
Tula Hidalgo Refinery
Mexico

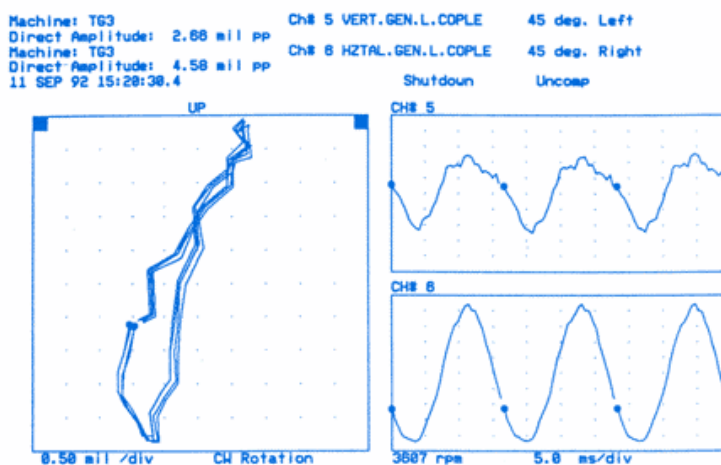
analysis of the recorded data showed that Bearings No. 1, 2, 3 and 5 were heavily preloaded. Bearings No. 2 and 3 showed a figure-eight shaped Orbit, as is shown in Figure 2.

Figure 2
Startup data showing figure-eight shaped Orbit

The presence of the heavily preloaded Orbits (indicated by the figure-eight shape), along with the high vibration levels, clearly indicated that the problem was a combination of severe misalignment and mass imbalance.

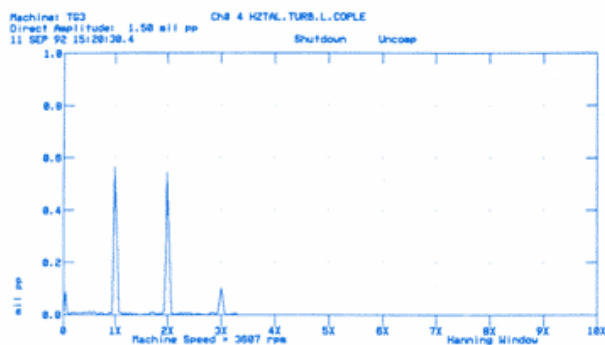
The horizontal probe of Bearing No. 2 showed a significant 2X vibration component (Figure 3). Bearing No. 2

The existence of a vibration component at twice running speed (2X), which has the same amplitude as the component at running speed (1X), might indicate misalignment.

Figure 3
Bearing No. 2 showing 2X vibration component

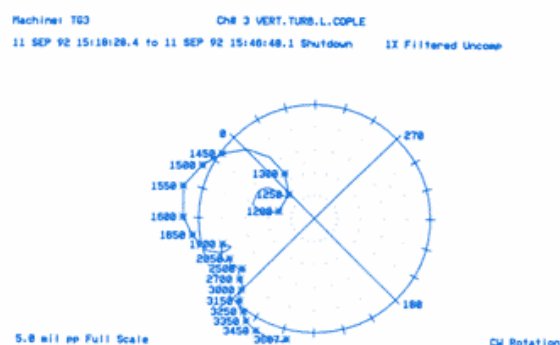
showed a vibration level of 6 mils at running speed (Figure 4). Bearing No. 4's vertical channel displayed a vibration amplitude of 8.5 mils at the first balance resonance and a residual level of 5.0 mils at running speed (Figure 5).

Figure 4
Uncompensated Polar plot of Bearing No. 2

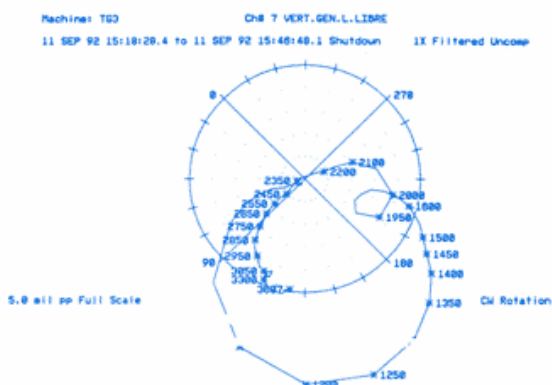
The uncompensated Polar plot (Figure 5) shows a high level of slow roll which indicates the generator's shaft is

bowed. This bowed condition is also the cause of the high vibration levels during the first balance resonance. The high vibration levels also show the rotors are operating near the pivotal mode.

Figure 5
Uncompensated Polar plot of Bearing No. 4

Due to the time and cost required to disassemble the turbogenerator and bring it to a balancing facility, plant personnel decided to attempt to balance it on-site. Plant personnel took the following factors into consideration in making their decision:

- Weights would be added or removed only at the generator's two balance planes.

- No attempt would be made to balance the generator alone to some minimum standard. Instead, they would attempt to balance both the steam turbine and the electric generator.

- They would try to obtain a balanced response between the vibration level during the pass through to the first balance resonance and the residual vibration level at the running speed for the entire train. ►

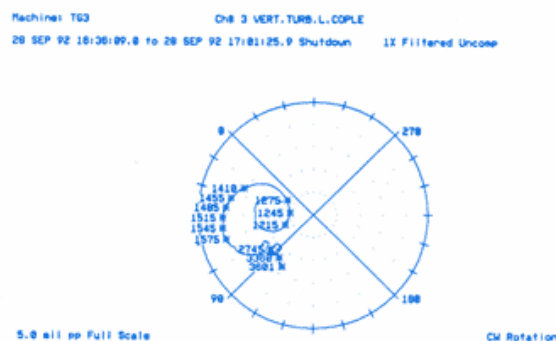
Figure 6
Uncompensated Polar plot of Bearing No. 2 after alignment

The turbogenerator was put on-line and is working reliably at full load. Vibration levels at every monitored channel decreased at critical speed and at running speed (Figures 6 & 7). Orbit/Timebase plots taken after the alignment correction are more elliptical (Figures 8 & 9), not the figure-eight

After the alignment correction, plant engineers balanced the machine train. Vibration levels were recorded on all
